Lessons Learned from the 2017 Hurricanes: A Technical Evaluation of Building Performance & the Impact of Code Adoption and Enforcement

TU2A: Resilience: Learning from the Past, Adapting to the Future

Dan Bass, FEMA Mitigation Assessment Team Program Manager, FEMA Stuart Adams, Associate, Environmental Services, Stantec Bill Coulbourne, Structural Consulting Engineer, Coulbourne Consulting

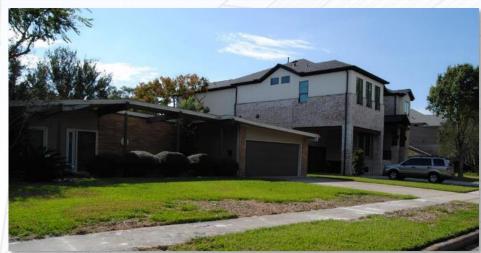
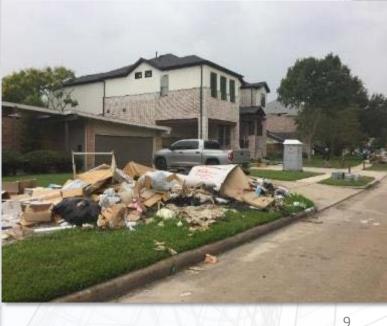
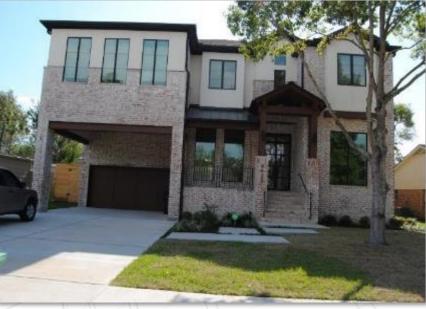
• Elevation matters - damage to non-

conforming buildings was noticeably greater than damage to NFIP-compliant buildings

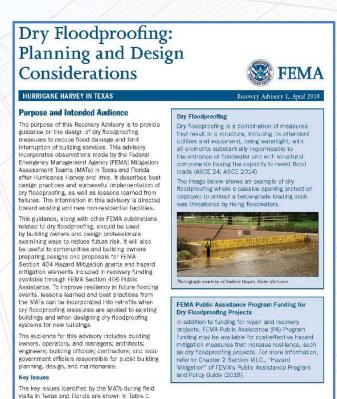
- Dry Floodproofing System Failures
 - Overtopping Failure of Opening Protection
 - Structural Failure of Flood Barrier
 - Failure to Identify and Protect Lowest Point of Entry
 - Failure to Maintain Structural Integrity of the Flood Barrier
 - Seepage Issues
 - Sanitary Sewer or Stormwater System Flows
- **Flood Vulnerability Assessments**
- **Planning and Pre-Design** Considerations
- **Design Considerations**

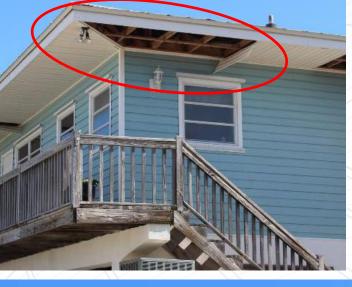
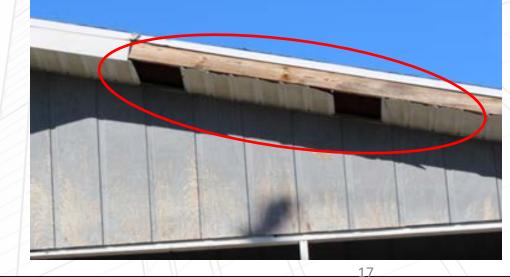
Soffit damage widespread

- Vinyl and • metal soffits damaged
- Fascia cover • loss common with damaged soffit
- Soffit Installation in Florida FEMA HURRICANE IRMA IN FLORIDA Purpose and Intended Audience Floride Building Code and International Code This Records Actively provides softly installation get block on Lickauros to much or records "Think im provisions of the 6th Editor (2017) Funda Building Code, Davidantial (FRCID) The administration for The 2015 k ternst anal Residential Code (140) serves as the basis tode for the Gri Libban (20). I JCII. I code specific amendments are added through the state's established orde dovelopmen this addisaty addides contractors and homeowners har may also be burpfor for braking of inists and dasjon reafassionals. coloctions/F - Wind damaged sofuls allowed wind driven rainto enter hullding envelopes, resulting in easily damage to building interiors. Write some water was blown into a lots through software, the cross of swater induces an exist sufficiency the cross of swater minister increased dramatically when the soft material was missing (Figure 1). Need for elements on of new to meet the 60h Edition (2014) DOR softs installation or tens. This Recovery Advinces Addresses · Settit design wind leads and installation in the Fonde Durchig Gode a histoline the solu-Soffit Yerd Soffit Design Wind Loads and Installation In the Florida Building Code REGS for reof verting protections. To avoid water only as solfs wonts, options much do at mining sofflive visional providing in other works of the Compliance with the Oth Edition (201-9 of the Complete entrine of Laten (22.1) of the 1 entries Funding Code () Bits is required threadeut, the state to be fiding semits issued ofter December 32, 2015 indial ge pickets to opport one reads. Exclusions from almosts, One sind aw-femity develops are created under the scape of the for all to enter the affic, or designing for an the arrive and the above or company of the investment of the Architer opportunity is to prove that there is a first inset for theoring, very laters of the very opportunity of account in each or approximation of the very opportunity of account is the very opportunity of account is a second theory and the very opportunity of the very opportunity opportun FBC6. Softi provisions in the GPr Fdi lon (5007) of FBC6 were updated from the provides (Strived from as follows:

- Soffit edges exposed to more wind
- **FL Recovery Advisory** 2, Soffit Installation in Florida

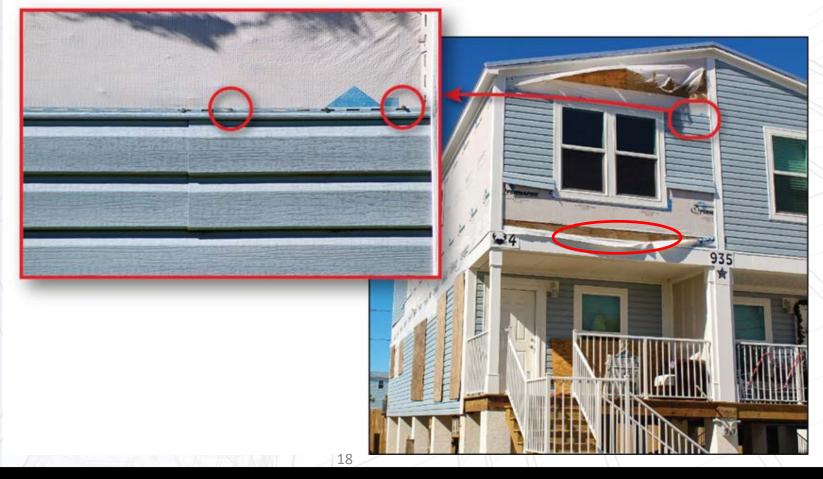
Wall Covering: Vinyl siding damage on 2017 construction – faulty installation factored into some failures

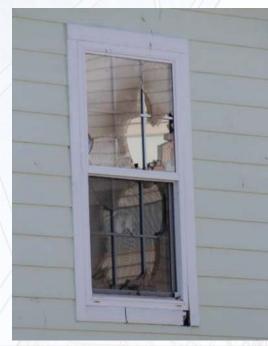
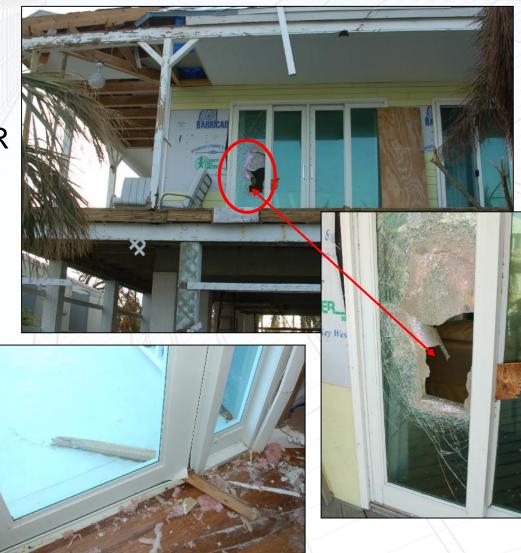
- Damage less
 common
- All sites visited are within ASCE 7 WBDR
- Both examples from Little Torch Key

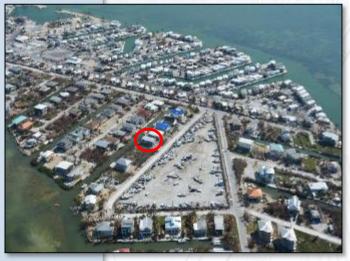
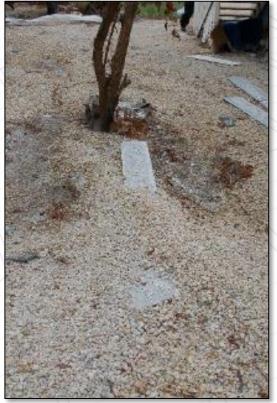
- Visited on pre-MAT
- Siding (wind) damage (preceded flood)
- Water depth 9 in (front) to 24 in (rear) above top of slab

Effective Zone, BFE: AE 11 ft NGVD Est. Depth of Water during Irma: ~ 1 ft above grade

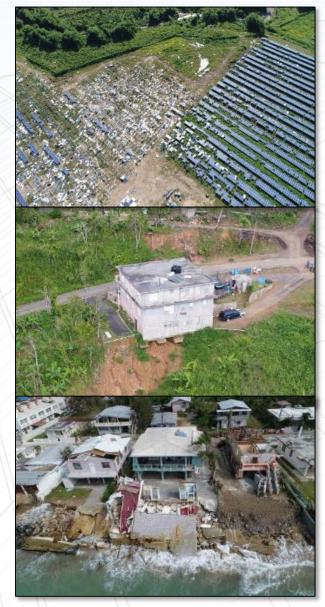
- Informal construction
 - Lack of continuous load path
 - Unpermitted
 - Not designed IAW Building Code
- Water intrusion through roofs and openings
- Rooftop equipment attachment
- Ground-mounted PV performance variable
- Siting
 - Landslide
 - Erosion
 - SFHA
 - Topographic Wind Speed-Up
- Corrosion Failures
 - Connections and Structural Members
- Tile Roof Attachment

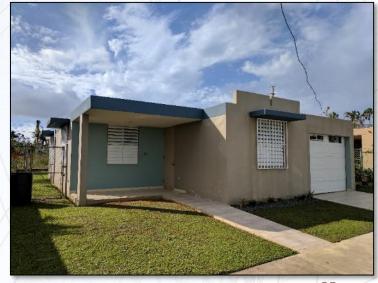
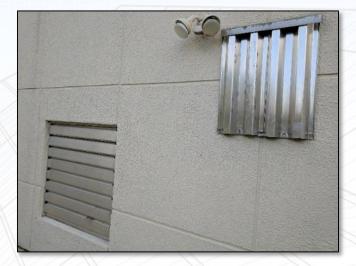
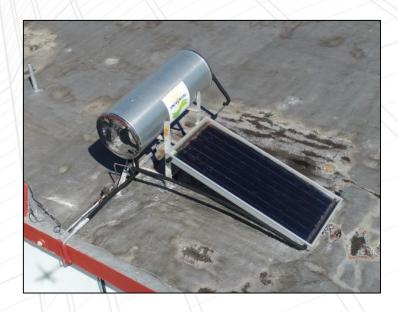
- Mitigation successes from FEMAsponsored, locally supported mitigation programs:
 - New Secure Housing Program
 - Wind Retrofits (e.g., fire station shutters)
- Rooftop solar water heaters
- Flood damage resistant materials

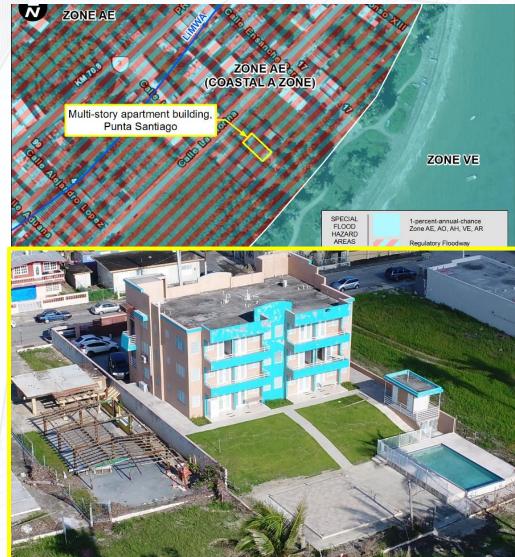
PR MAT Location: Punta Baja, Humacao

- Direct hit from Maria
 - High winds, storm surge, large waves
 - Some buildings saw 7-9 feet (2.1-2.7 meters) of surge
 - 2005 & 2009 FIRMs show AE and V Zones
 - Advisory Mapping adds Coastal A Zones
- Apartment building elevated on fill to 2009 BFE did not flood (but many at grade did)
- Elevated wood-framed building destroyed

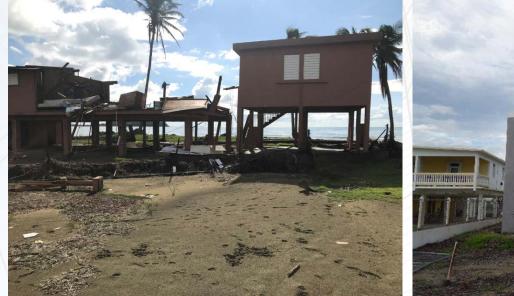
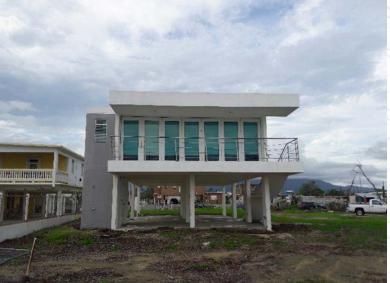
PR MAT Location: Punta Baja, Humacao

- Elevated wood-framed house that was destroyed and that survived
- The elevated concrete house performed well

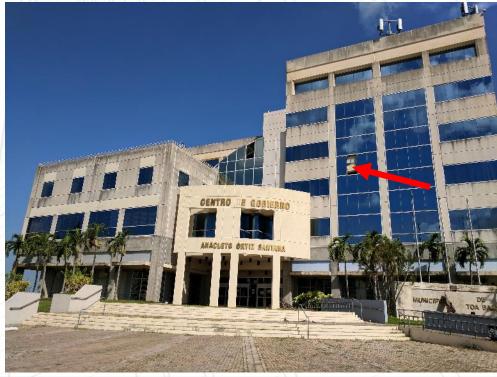
PR MAT Location: Toa Baja Municipal Building

- Did not flood in 2017 hurricanes
- Underground parking structure
- Roof and glazing damage allowed water intrusion requiring the building to be closed

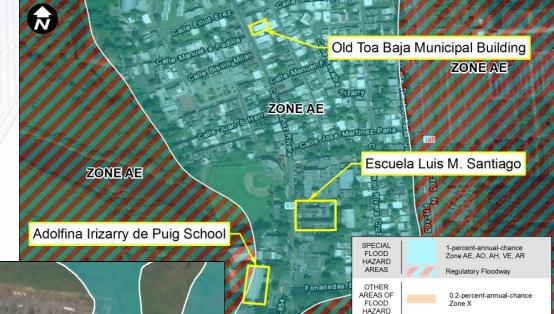
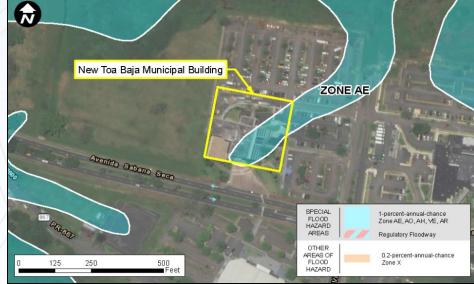
PR MAT Location: Toa Baja Municipal Building

New building in 1996 to reduce flood risk

• Still in SFHA but elevated on fill

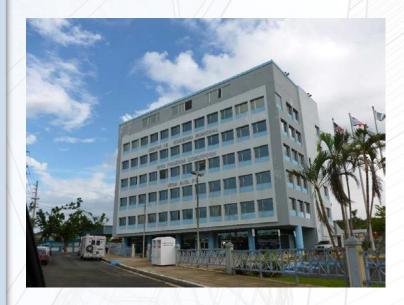
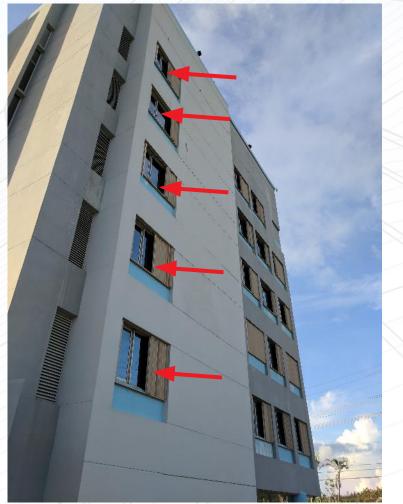
PR MAT Location: Vega Alta Municipal Building

- Shutters on east windows only
- Glazing failures led to water intrusion

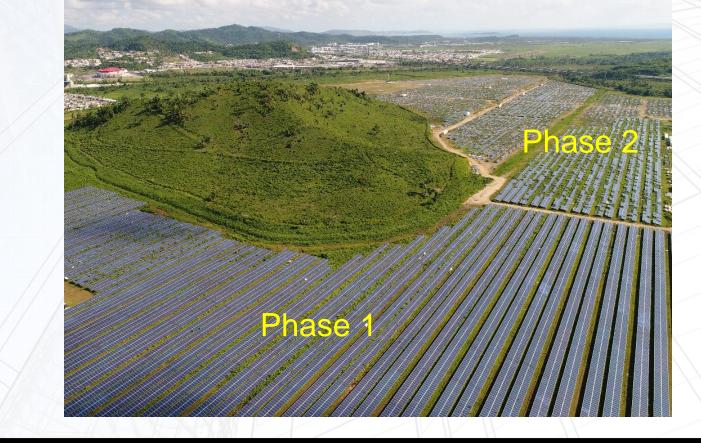
PR MAT Location: Reden Solar Array, Humacao

- Large ground-mounted PV array
- Topography & construction may have contributed to performance differences between phases 1 and 2...

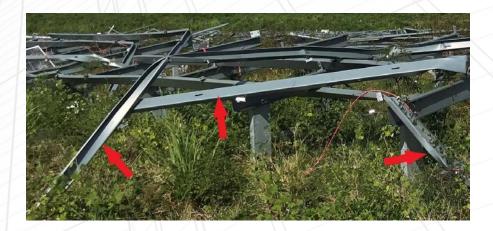
PR MAT Location: Reden Solar Array, Humacao

- Deformed hat clip still bolted to its supporting lateral rail
- PV panel was lifted out of position when hat clip was bent upward by wind uplift pressures
- Deformed steel lateral rails
- C-shaped lateral rail connections were unable to maintain connection to the steel beams in high winds.
