HM-4

MEDICAL/DENTAL CLINIC			
HAZARDOUS MATERIAL REMOVAL BUILDING 201 PLAN AND EXTERIOR ELEVATIONS			
SIZE	CODE IDENT. NO.	DRAWING NO.	
F	XXXXX	8144543	
		CONST. CONTR. NO.	
		SCALE: AS SHOWN	
		SPEC. 11996048	
		SHEET 38 OF 316

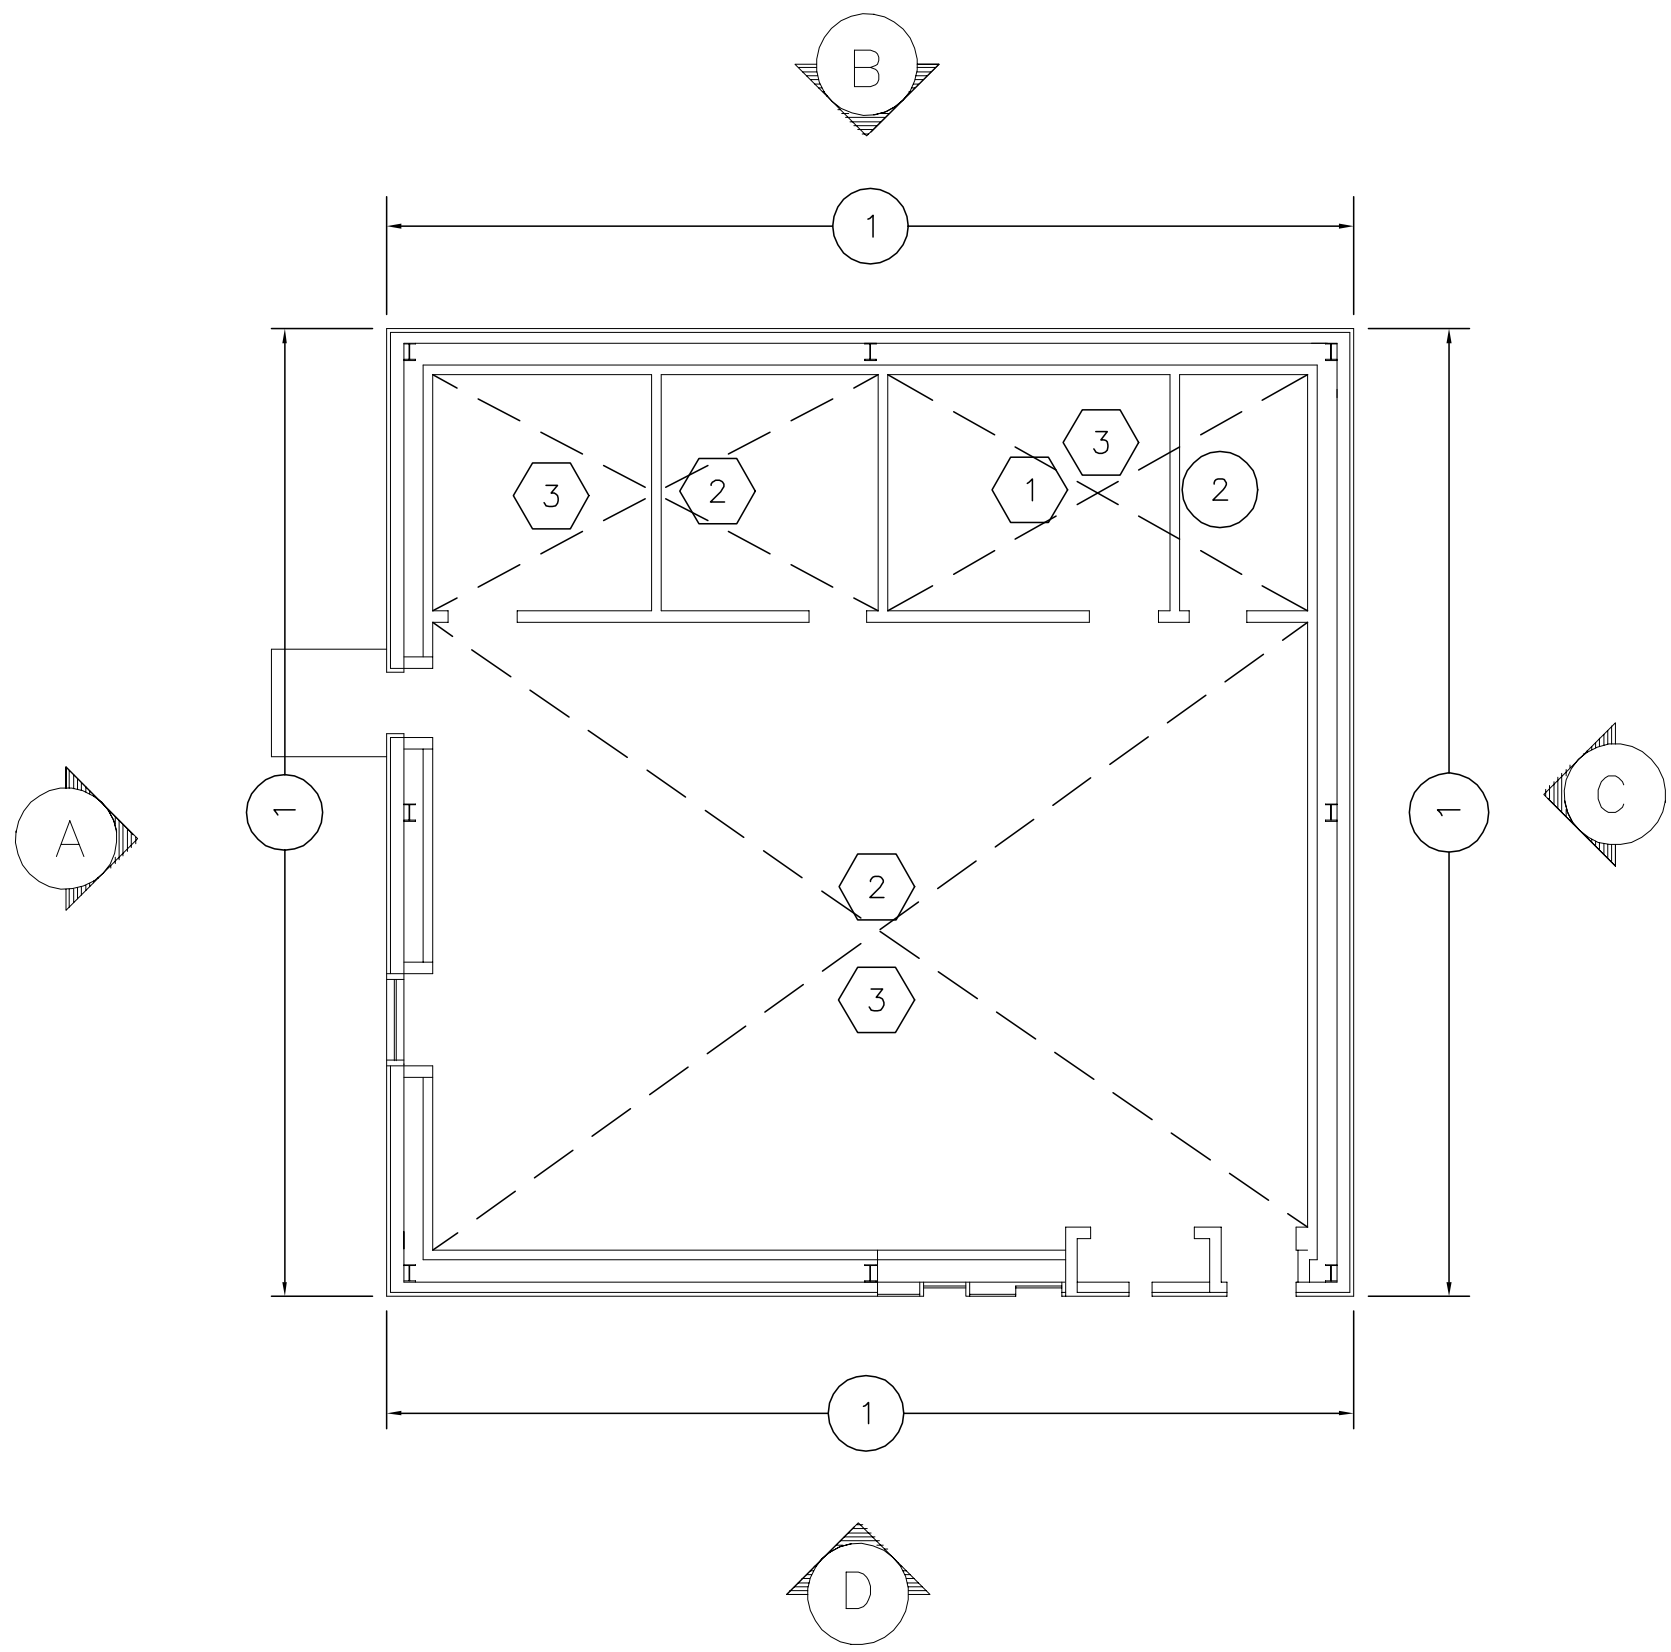
BLDG. 201 - FIRST FLOOR PLAN
SCALE= 1:100

NOTE:
THE CONTRACTOR SHALL ASSUME THAT ALL ROOMS ON THE FIRST FLOOR OF BUILDING 201 CONTAIN FLUORESCENT LIGHT FIXTURES WITH MERCURY CONTAINING LAMPS.

CORRUGATED METAL SIDING COATED WITH LCP AND SPRAY APPLIED AC TREATMENT
